Subject: Adding or Installing a Rearview Camera
Models Years Affected: 2019 - beyond
Models Affected: Chevrolet Silverado/GMC Sierra Full-Size Pickups and Chassis Cabs with Box Delete (ZW9) or Box Removal
Origination Date: June 21, 2019
Revision Date: November 16, 2022

2019 and above Full-size Pickups and Chassis Cabs (New Body Style)

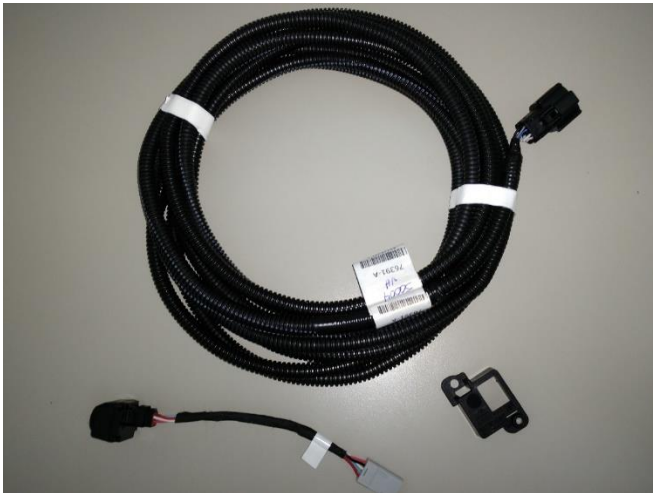
NOTICE: Do NOT modify the camera enclosure in any way or form...this could damage the sealing integrity of the camera and result in damage to the internal components
