Subject: Adding or Installing a Rearview Camera
Models Years Affected: 2019 - beyond

Models Affected: Chevrolet Silverado/GMC Sierra Full-Size box delete (ZW9) Pickups and Chassis Cabs (NEW body style)

2019 and above Full-size Pickups and Chassis Cabs (New Body Style)

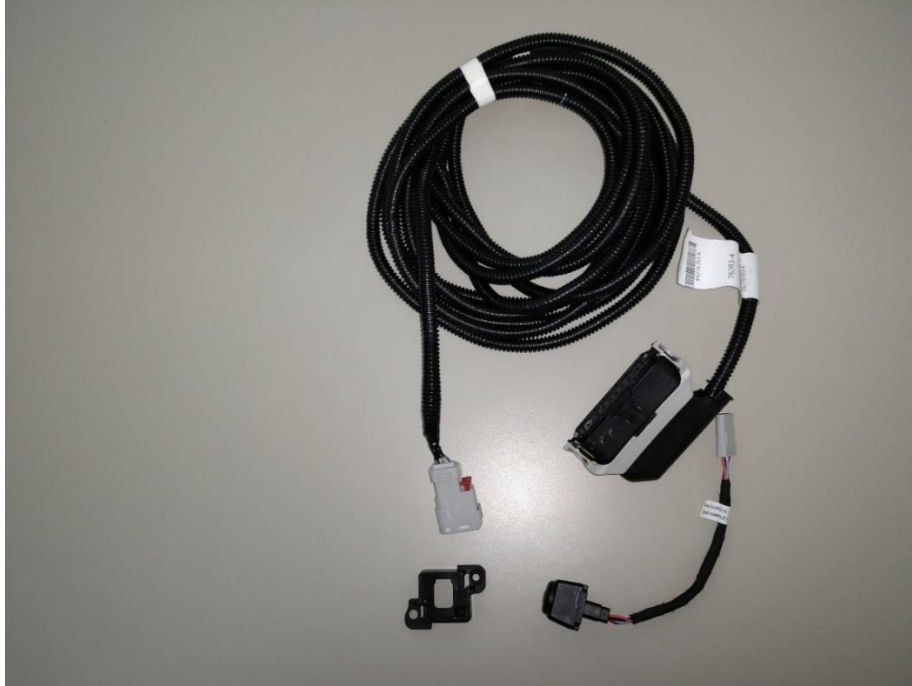
Kit P/N 84759865 (for use with 5N5 and IOR radio)		
Contents:		
Note: Kits are not available from Service Parts – Only Individual pieces as listed below		
Component	Part Number	Quantity
Camera (Analog)	23390515	1
Bracket	84809886	1
Harness	84682149**	1
**refer to UI TSB 174 for details on possible wiring updates		
Attachment Clip	84606061	12
