**Subject:** Adding or Installing a Rearview Camera  
**Models Years Affected:** 2019 - beyond  
**Models Affected:** Chevrolet Silverado/GMC Sierra Full-Size box delete (ZW9) Pickups and Chassis Cabs (NEW body style)  
**Origination Date:** June 21, 2019  
**Revision Date:** September 19, 2022

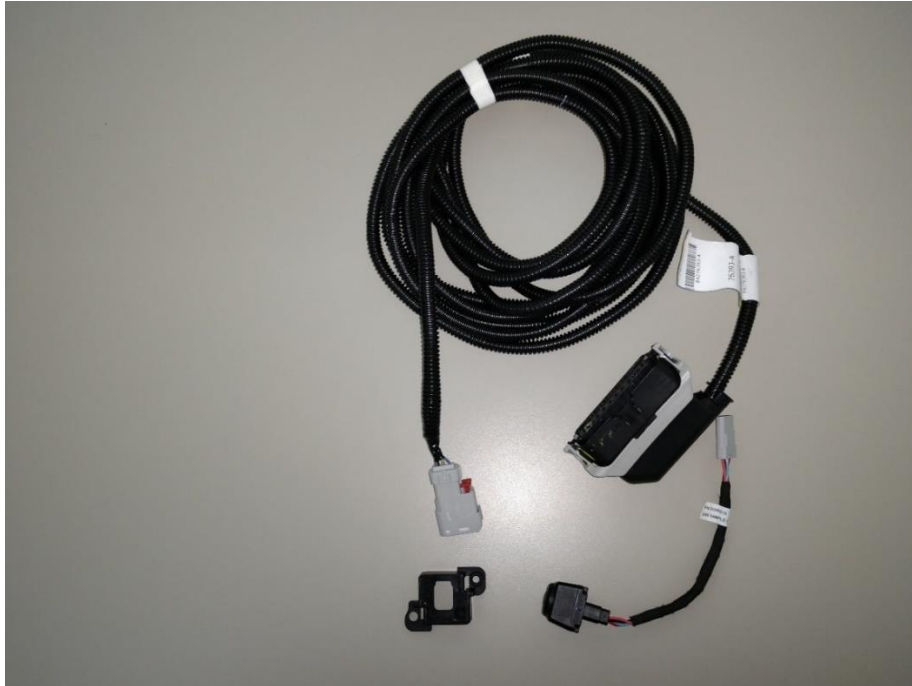
<b>Kit P/N 84759865 (for use with 5N5 and IOR radio)</b>		
<b>Contents:</b>		
<b>Note: Kits are not available from Service Parts – Only Individual pieces as listed below</b>		
Component	Part Number	Quantity
Camera (Analog)	23390515	1
Bracket	84809886	1
Harness	84682149**	1
<b>**refer to UI TSB 174 for details on possible wiring updates</b>		
Attachment Clip	84606061	12

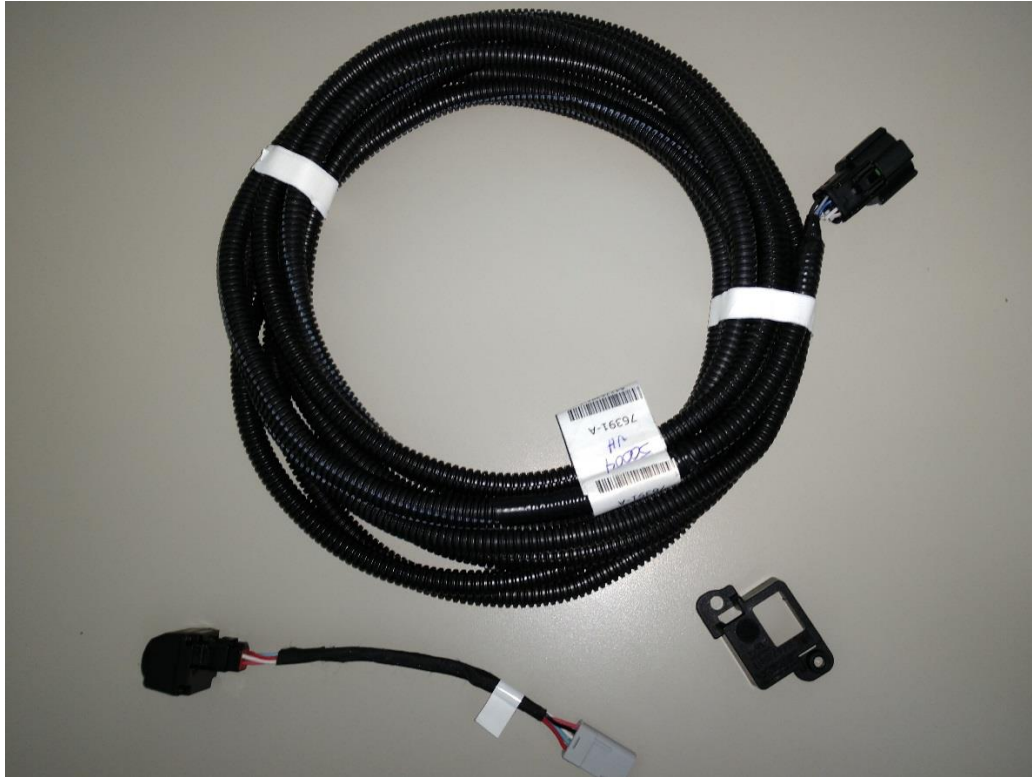
Kit P/N 84759864 <b><u>(for use on a chassis cab vehicle only)</u></b>		
<b><u>Contents:</u></b>		
<b>Note: Kits are not available from Service Parts – Only Individual pieces as listed below</b>		
Component	Part Number	Quantity
Camera	23390515	1
Bracket	84809886	1
Harness	84682148	1
Attachment Clip	84602061	12

\*Attachment clip not shown

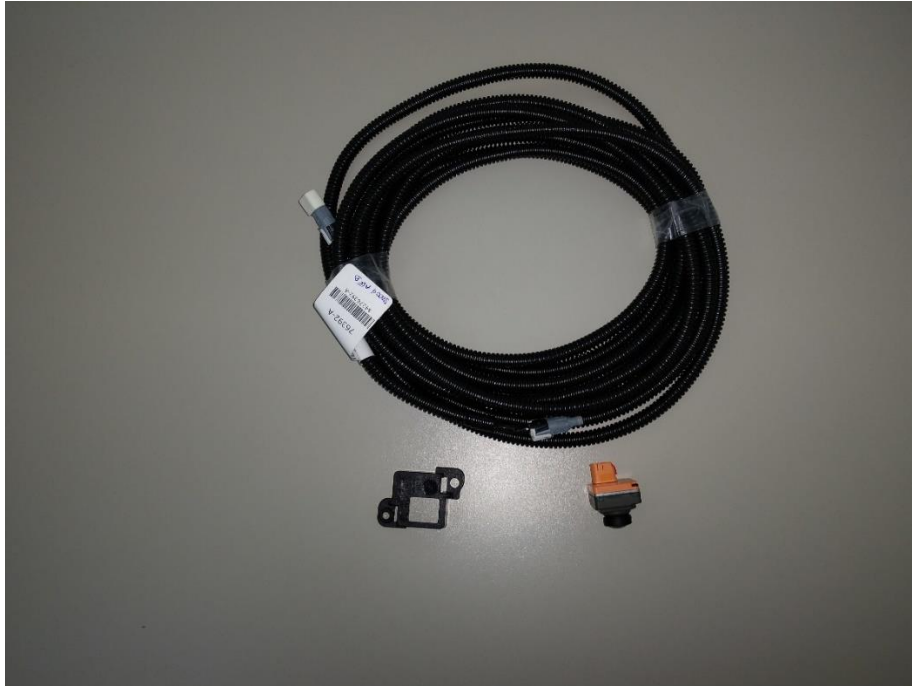
Kit P/N 84754199 <b>(for use with 5N5 with an IOS or IOT radio)</b>		
<b><u>Contents:</u></b>		
Note: Kits are not available from Service Part – Only Individual pieces as listed below		
Component	Part Number	Quantity
Camera	84383355	1
Bracket	84809887	1
Harness	84276392	1
Attachment Clip*	84602061	12

\*Attachment clip not shown
