**Subject** Installation of Upfitter (AUX) Switches  
(9L7) components

**Model Years Affected** 2022i - 2024 - Current

**Models Affected** Chevrolet Silverado  
GMC Sierra

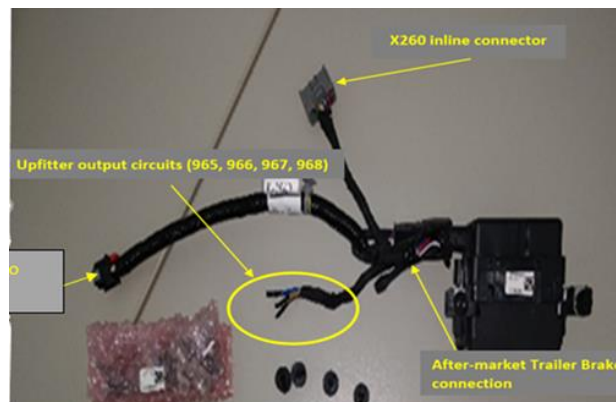
**NOTE:** For all vehicle trim level applications the components shown below will need to be installed

**Install Procedure #1 = Chevrolet WT (GF5), Custom (GF2), Custom TB (GPZ), and GMC Pro (GFF)** (Note for the new IP design kits are not yet available use P/Ns for obtaining parts for retrofitting a vehicle not ordered with the 9L7 option)

**Note:** because these trim levels are carry-over IP from the previous generation of trucks you can use kit part number 84942073 which will include the components shown in the image above. You will not use the retainers as the harness routing has changed and they are no longer needed.

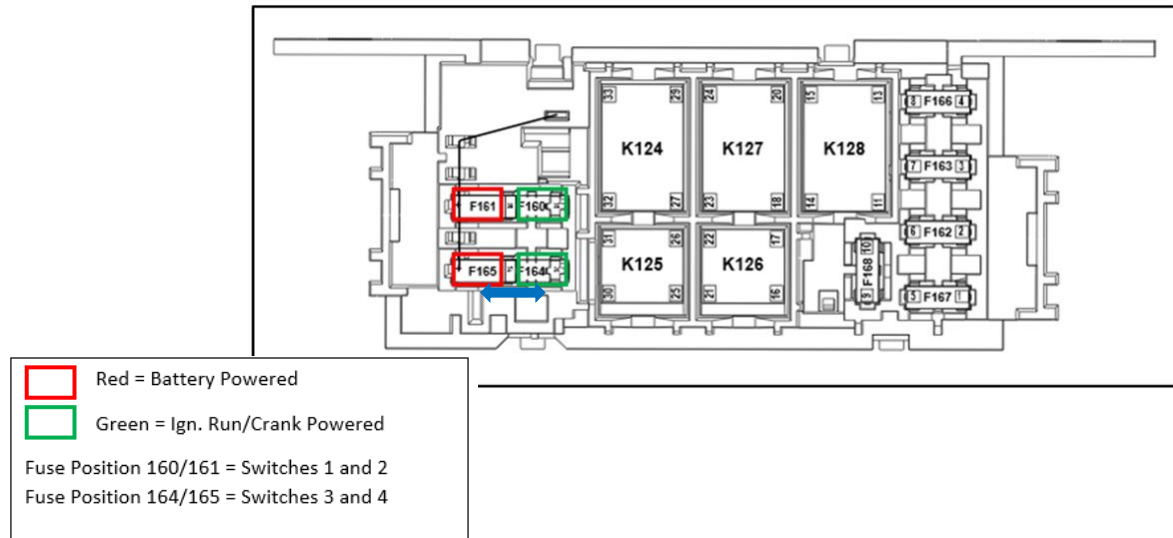
The upfitter switches are defaulted to being battery powered but can be reconfigured in pairs to operate only when in accessory/ignition ON by relocating one or two fuses as shown below.
