UI Bulletin #122b

Subject: CHMSL/Cargo Lamp Wiring For Aftermarket Bed Cap Topper

Models Affected: 2014 Chevrolet Silverado 1500
2015-2018 Chevrolet Silverado
2014 GMC Sierra 1500
2015-2018 GMC Sierra

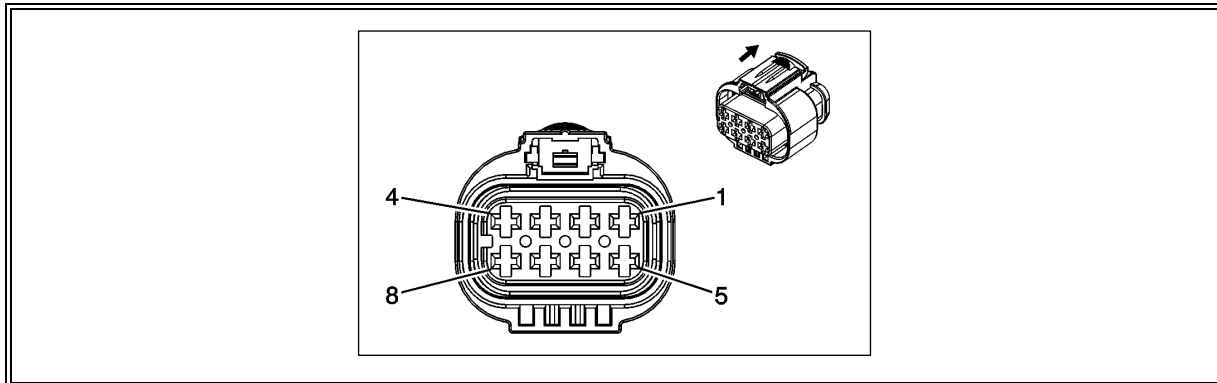
X63A- Rear Junction Block – Connector X6 (2014-2015)

- Harness Type: Pending
- OEM Connector: 13581768
- Service Connector: **Not yet available**
- Service by Harness - See Part Catalog
- Description: Rear Bed Cargo Lamp

X63A Junction Block - Rear Body X6						
Pin	Size	Color	Circuit	Function	Terminal Type ID	Option
1	0.75	VT/GY	1054	Stop Lamp Supply Voltage	I	-
2-3	-	-	-	Not Occupied	-	-
4	0.5	RED	1430	Exterior Courtesy Lamp Supply Voltage	I	-
5-6	-	-	-	Not Occupied	-	-
7	0.5	BLK	1750	Ground	I	-

Trucks equipped with the under-rail bed lighting option will already have an X6 connector at the rear body junction block X63A, which will be removed and discarded. Obtain an appropriate length of 14g wire to run from the rear body junction block up to the CHMSL wiring for the cap or topper. Use terminal part # 1-968857-3 in Lear Tray 7, along with wire seal part # 828905-1 in Lear Tray 16 and connect to one end of the wire. Disconnect the X6 connector at the Rear Body Junction Block and remove the rubber cavity plug in terminal position 1 and discard. Install the terminated lead you just made into the X6 connector terminal 1. Run the wire up to the CHMSL for the cap or topper and connect. The ground for the cap or topper CHMSL will need to be made to an appropriate ground.

Trucks not equipped with the under-rail bed lighting option will have a dummy connector at the X6 position of the rear body junction block. The X6 connector body is not available separately, but can be obtained by ordering the under-rail bed lighting harness GM part number 22878806. The harness will come with terminals/wiring in positions 4 and 7. You will need to remove the wiring from terminal 4 and discard. Move the rubber cavity plug from terminal position 1 into terminal position 4. Obtain an appropriate length of 14 ga wire to run from the rear body junction block up to the CHMSL wiring for the cap or topper. Use terminal part # 1-968857-3 in Lear Tray 7, along with wire seal part # 828905-1 in Lear Tray 16 and connect to one end of the wire. Install the terminated lead you just made into the X6 connector terminal 1. Terminal 7 is a ground circuit used for the under-rail bed lighting and it can be used to ground the CHMSL for the cap or topper, if desired. If terminal 7 is not used remove the terminal and install a rubber cavity plug or cut off the additional wiring, leaving a couple inches of wire and seal the end of the wire.
