Subject: Rear Spring Shackle Bolt Length
Models Years Affected: 2007 and beyond
Models Affected: Chevrolet Silverado
GMC Sierra
w/ZW9 or Pick Up Box Removal
Origination Date: September 7, 2016
Revision Date: N/A

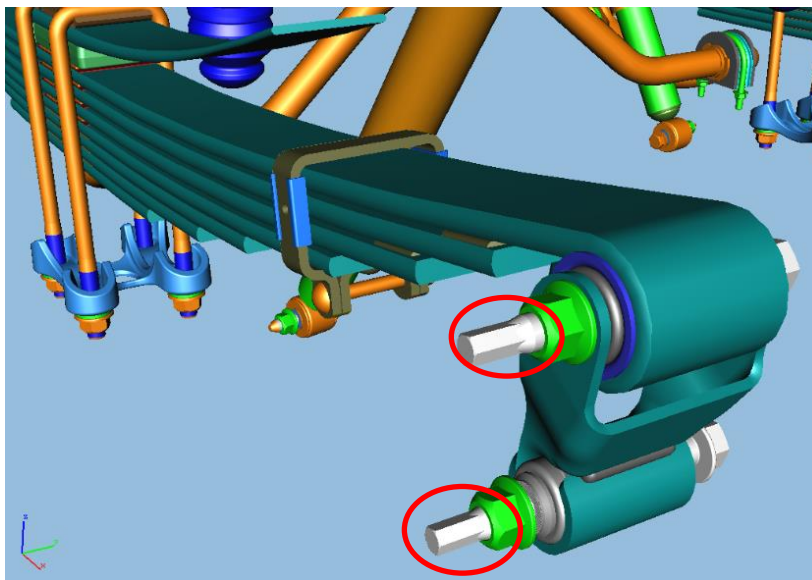
Upfitter/Service body and equipment installers have often expressed concerns regarding the “extra” length of the rear leaf spring shackle bolts interfering with the installation of the body or equipment.

The bolts for rear spring shackles have a hold & drive feature requirement for vehicle assembly. This feature adds extra length to the bolt required for the vehicle assembly process and cannot be eliminated.

IMPORTANT NOTICE: Body Builders/Upfitters can cut the extra length off this bolt, however they **MUST** maintain at least 3 threads **visible** on the end of the bolt after the joint is clamped.
