UI Bulletin #191

Subject: Cautionary – NO Drill/Air Bag Zones – Zevo Cargo Van
Models Affected: Bright Drop Zevo Cargo Vans
Models Years Affected: 2022 and beyond
Origination Date: May 3, 2023
Revision Date: N/A

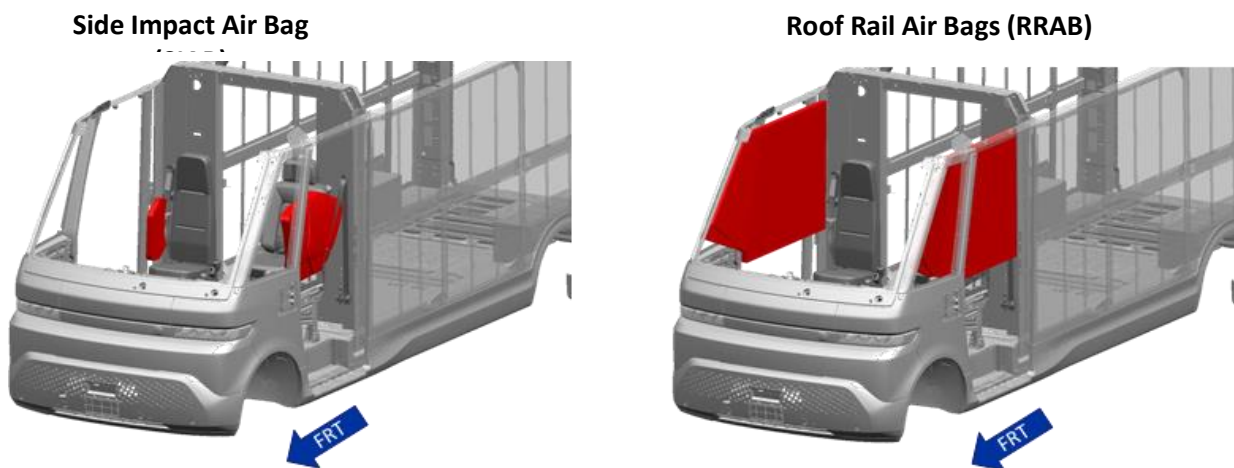
Air Bag Deploy Zones:

Upfitters need the locational information for the air bag deployment and the NO DRILL zones for the purposes of installing equipment.

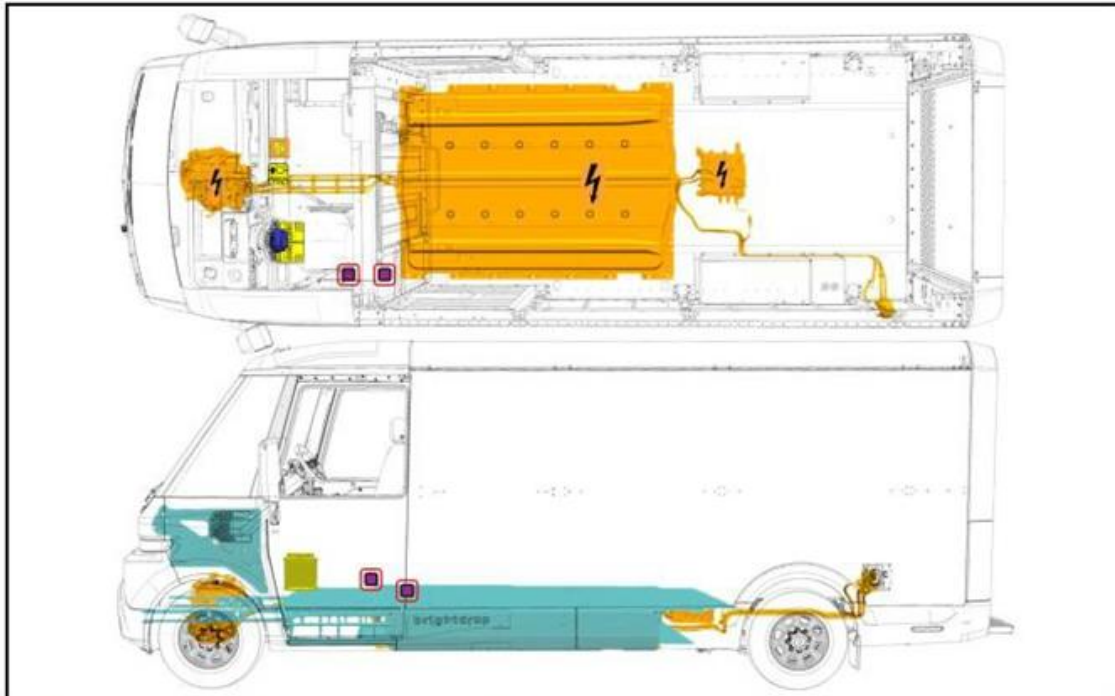
MY22 FWD

NO Drill Zones

DO NOT CUT ANY ORANGE COLORED HIGH VOLTAGE CABLES	Identification Number	Version Number	Page Number
	5G5-21101	1	1

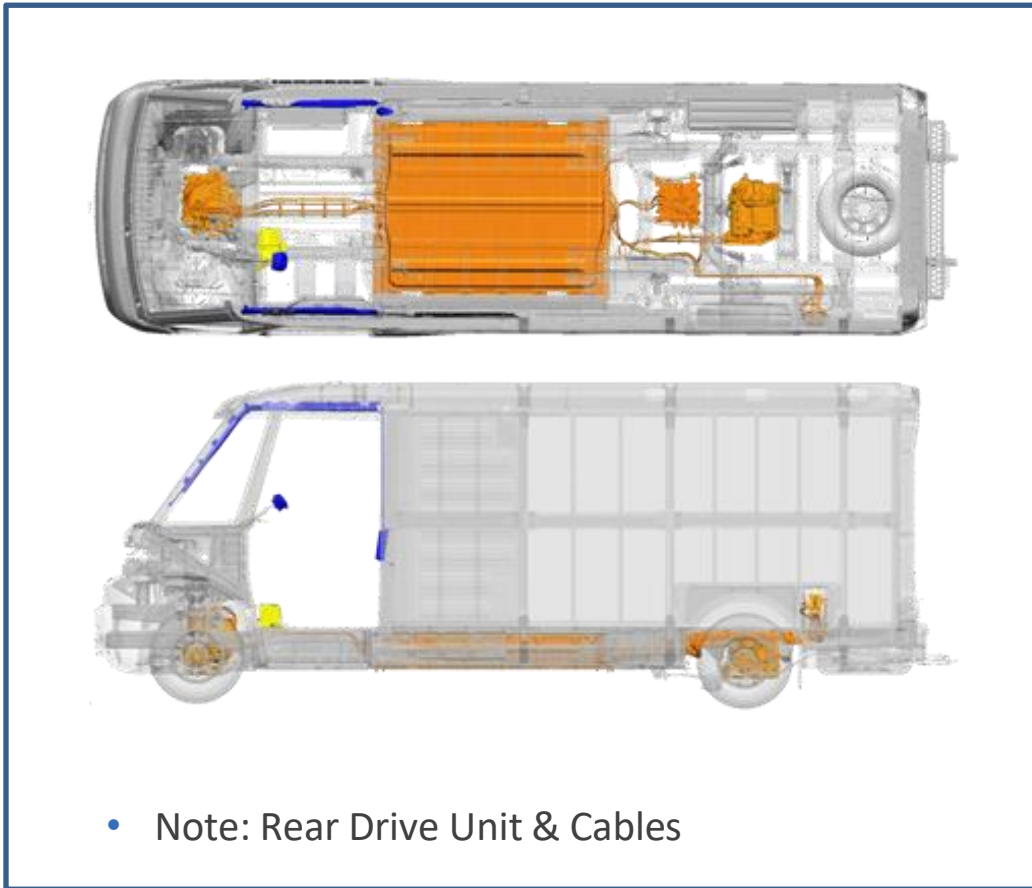
MY23 AWD

- Underbody content:
 - HV Battery (orange)
 - HV Cables/Modules/Drive Units (orange)
 - 12V Wiring (green)
 - Brake Lines (red)
 - HVAC Plumbing (Pink)

No drilling above HV Battery
No cutting of orange HV cables
No modifications to HVAC Plumbing

DC Charging Manual Release Cable

HV Battery

Charge Port

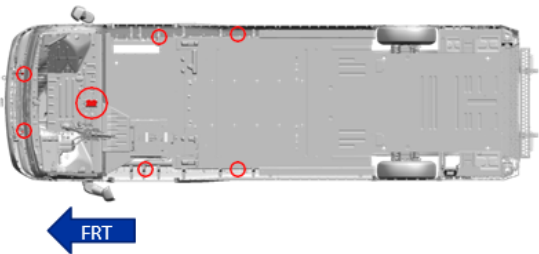
<h3>SRS Airbag Module & Impact Sensors</h3> <ul style="list-style-type: none">• SRS Airbag module centrally located under Lower IP Bin• 6 Impact Sensors

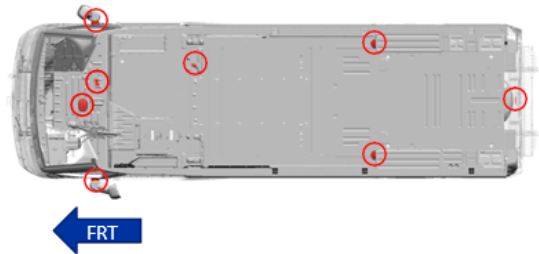
<h3>Security Access Antennas</h3> <ul style="list-style-type: none">• 8 Key Fob Antennas• Covering antennas will impair keyless entry/exit performance• Keyed lock access at rear door
